Manh Choh Project Permittee Responsible Mitigation Plan

December 30, 2021

1.1 INTRODUCTION

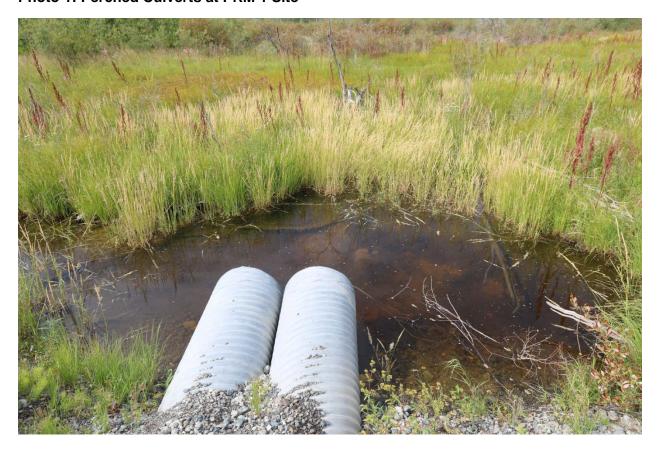
Photo 1: Perched Culverts at PRM 1 Site

PRM Site #1 is at the base of the Tetlin Hills, approximately mile 6 of the Tetlin Village Road. A wetland swale with a seasonal stream flows from the hills, meets the road, flows (at higher water levels) through two perched culverts downstream to a large wetland complex. The current culverts are perched, and only allow water to flow downstream during higher flow events. At lower volumes, water ponds and backs up on the upstream side of the roadway (Photo 1).

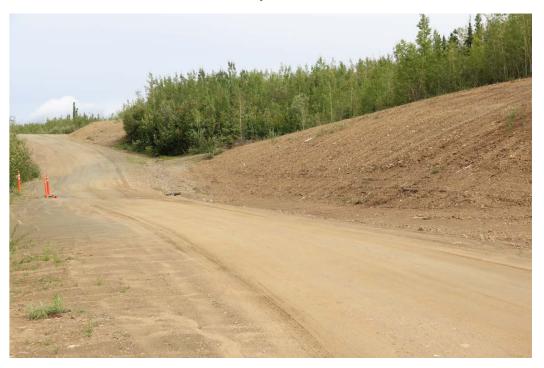
PRM Site #2 is located higher in the hills where the adjacent wetlands receive seasonal flow from the hillside above it, but do not have a clear surface connection to the larger wetland complexes below. The wetland swale at PRM Site #2 is adversely affected by sediments that are eroding from the road cut above and filling adjacent wetlands (Photo 2). The wetlands in the swale are retaining sediment but are slowly filling. The current culvert has filled with sediment, creating ponding and overflow on the roadway. The adjacent drainage shown in Figure 3 south of this hillslope is also filling with sediment. PRM Site #2 will be designed to find a lasting solution to the aufeis and erosion issues, while enhancing the downstream wetlands with reduced sediment.

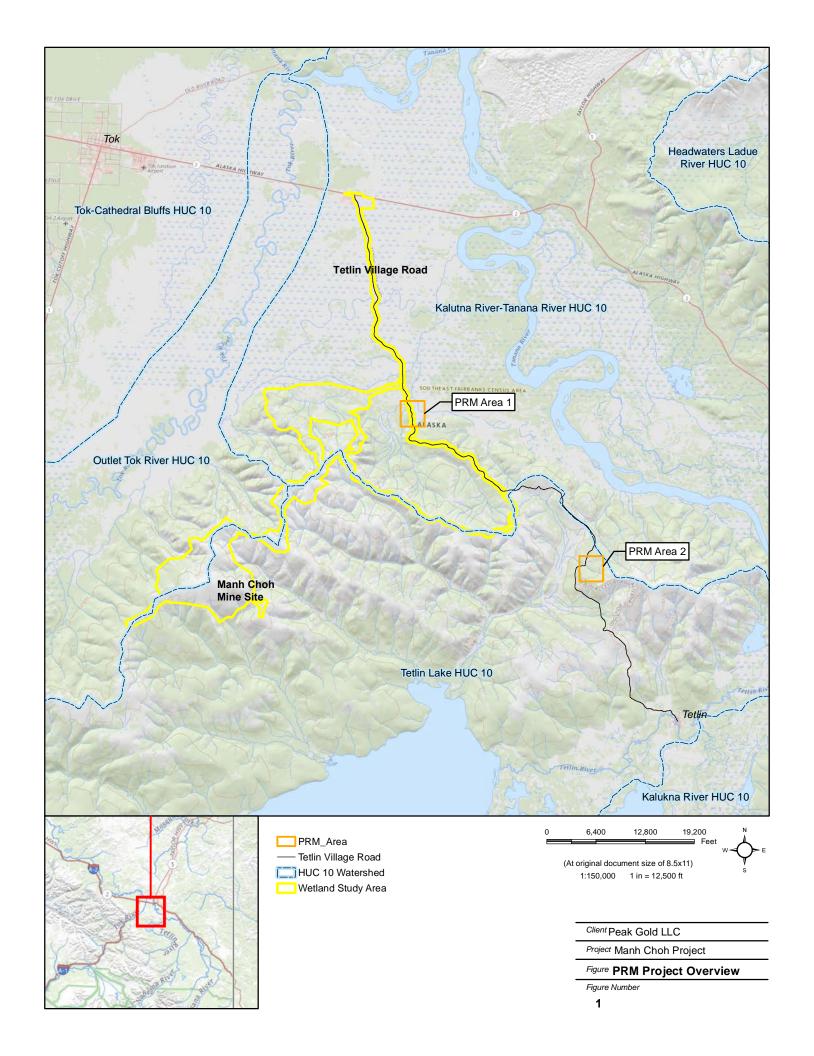
Figure 1 provides an overview showing the location of the two PRM sites in relation to the Manh Choh project and Tetlin Village Road.

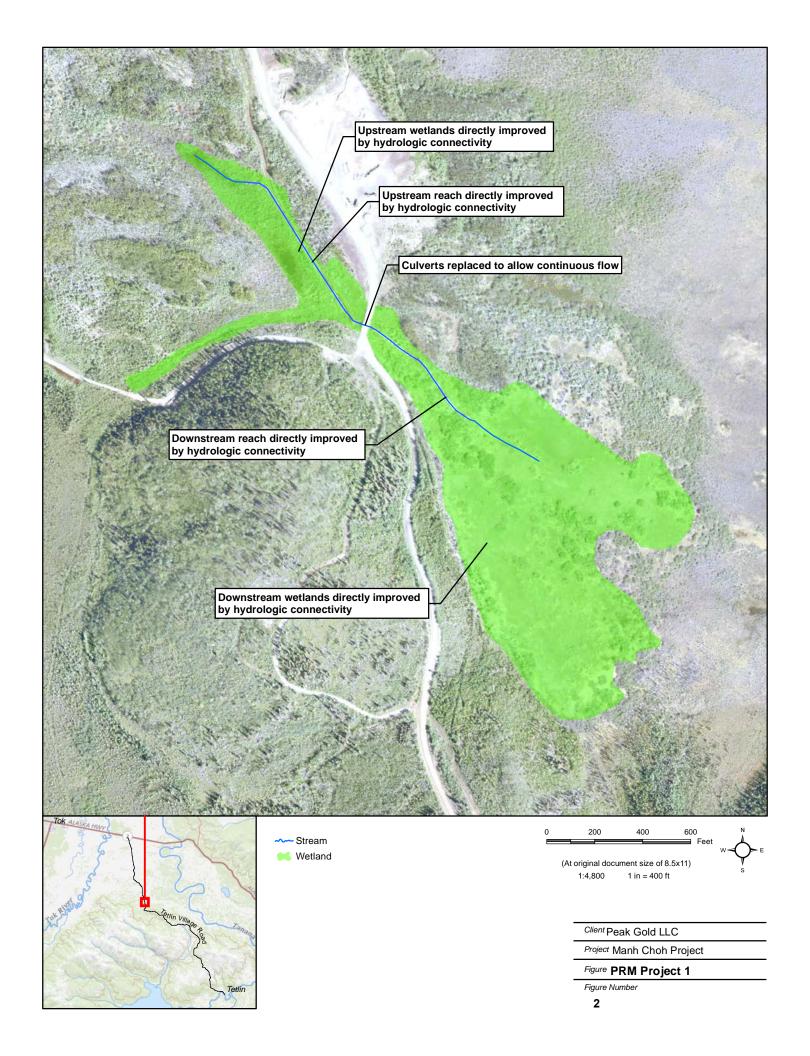
Figure 2 shows the area where culvert replacements will enhance downstream wetlands and waters. After the replacement of culverts at this location, the seasonal stream will be able flow uninterrupted to the east side of the roadway and into the larger wetland complex at the base of the Tetlin Hills. In addition, downstream overland flow from the seasonal stream will maintain soil moisture in the wider swale, likely reducing the encroachment of the deciduous shrubs and saplings along the outer edges of the swale. A better bank of culverts will also provide unobstructed flow during flooding events, both upstream and downstream of the road, based on spring breakup, snow melt, or overbank flooding from the Tanana River.

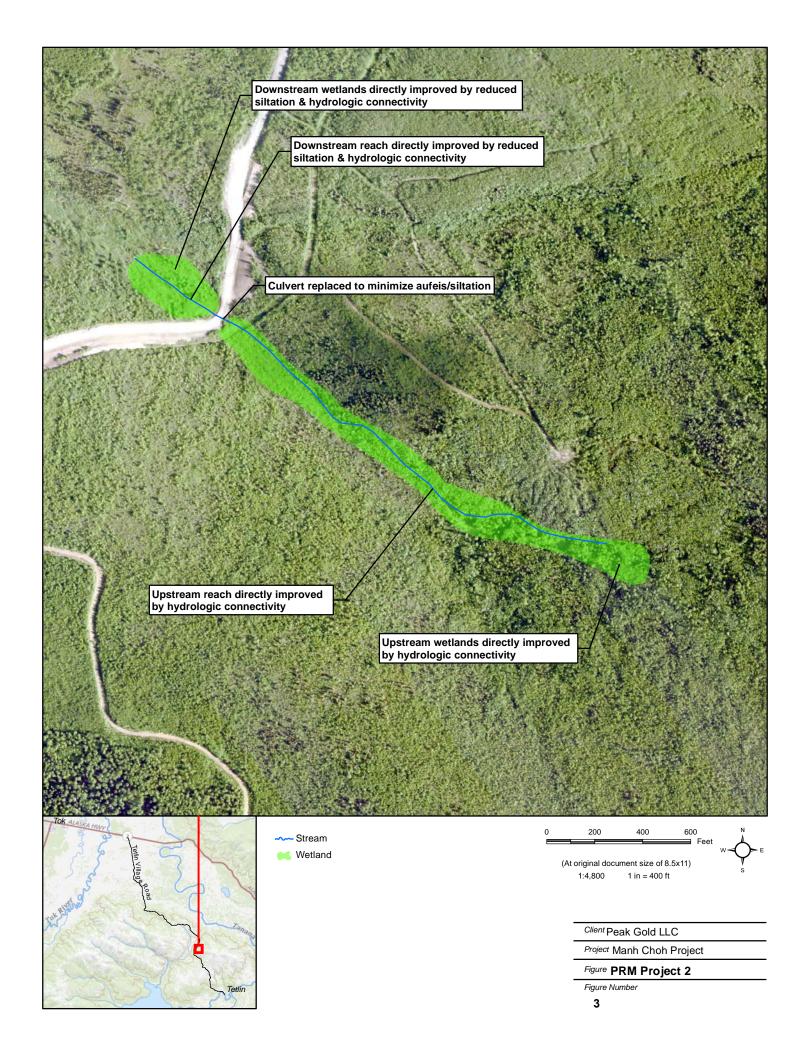
Figure 3 shows the area where culvert replacements will enhance downstream wetlands and waters for the PRM #2 site. Properly sized and placed culverts will allow overland flow to continue downstream without ponding or overflowing the roadway. Downstream wetland floodplains will receive less road based sediment, and vegetation growth should provide greater cover and diversity because of it.
